SWEET ARROW LAKE DAM

NDI NO. PA-00680 DER NO. 54-102

PHASE I INSPECTION REPORT NATIONAL DAM INSPECTION **PROGRAM**

APRIL 1979

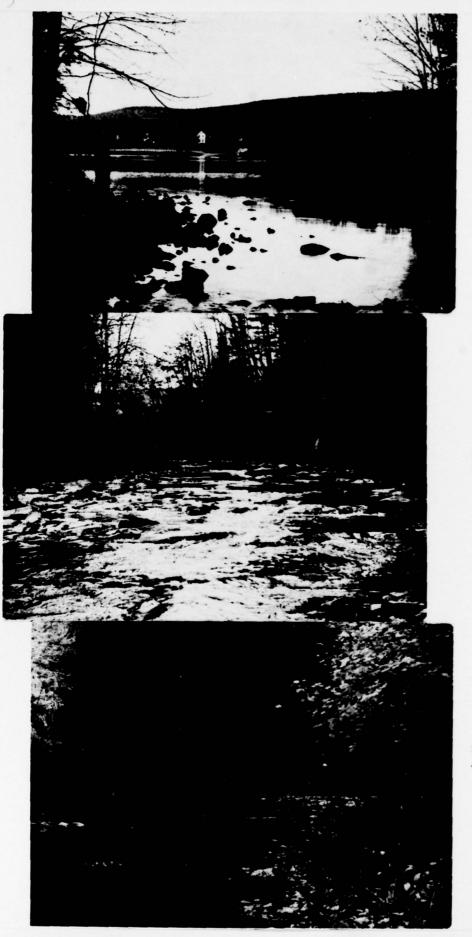
> PA-680 PLATE E-III

Entrance to Spillway

Spillway Over First 200 Feet

Spillway Channel Just Above Drop

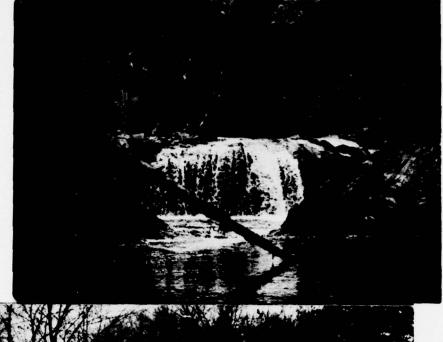
Spillway

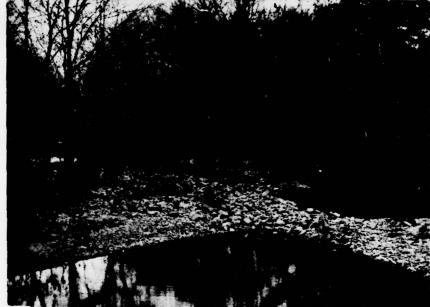
The conduit outlet ends in a small pool, which is closed off by a dirt access road (See Plate A-II, Appendix A), and prevents a free flow. Considerable siltation has occurred in the conduit. It appears, however, that sufficient opening is still available in the large conduit to pass the discharge flow of the 18-inch upstream blowoff valve. The spillway is located in the left hillside beyond the previous dam abutment. The channel is cut in the rock and was in good condition. There is no concrete weir and some brush near the left entrance causes a small obstruction. The discharge channel is rather flat over the first 300 feet and then drops vertically over natural rock to the stream.

Conduit Outlet With Creek in Background
